## Jag Mag article - Warren Tait

## Jaguar E Type 1969 S2, 4.2, 2+2

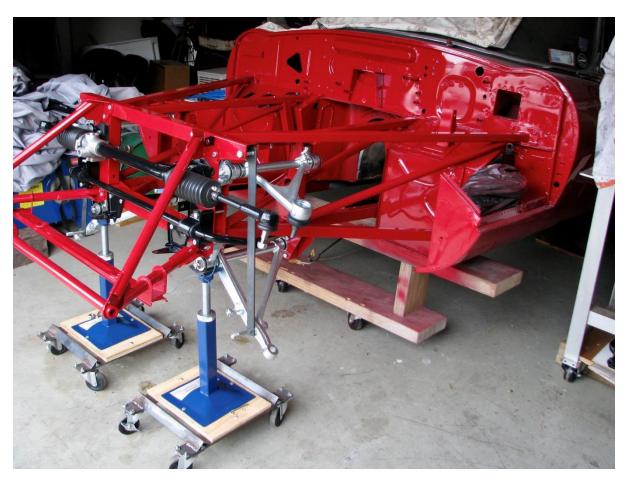
New nolathane bushes and rubbers were fitted to all suspension joints, brake calipers were completely rebuilt after plating then painted. The rebuilt suspension arms, wheel hubs, rotors, calipers and steering rack were refitted.

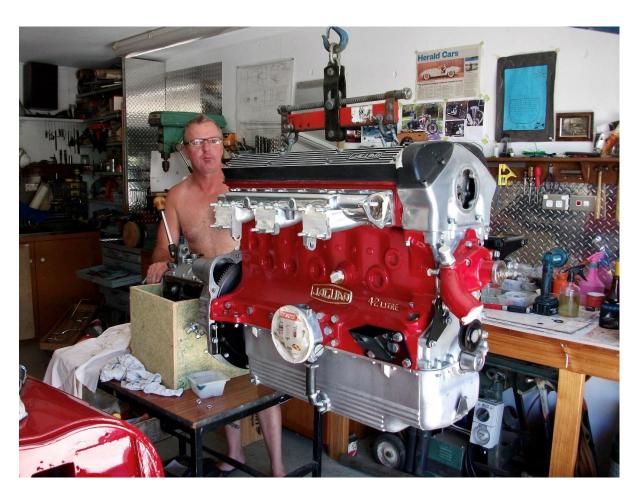
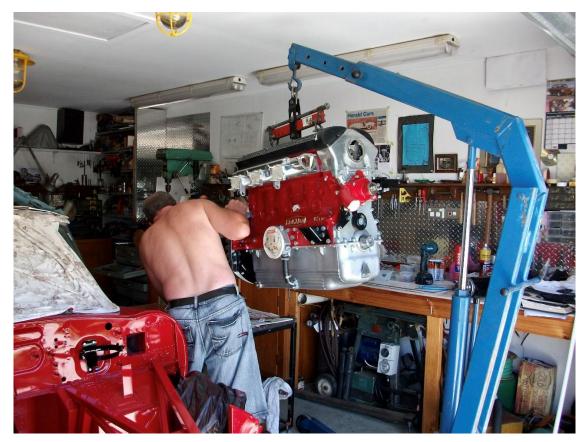
Next it was time for the engine and gearbox. This proved quite a task with so many new surfaces to protect from accidental damage, so a good friend was essential for this task.
